STREET HOMELESS SOLUTION – PROVISION OF A HOSTEL

Use of former Army Barrack at Ordnance Road Aldershot for a homeless hostel and request for Capital Funding

RE: ATC Hut at 259 North Lane, Aldershot

Asbestos Survey Report

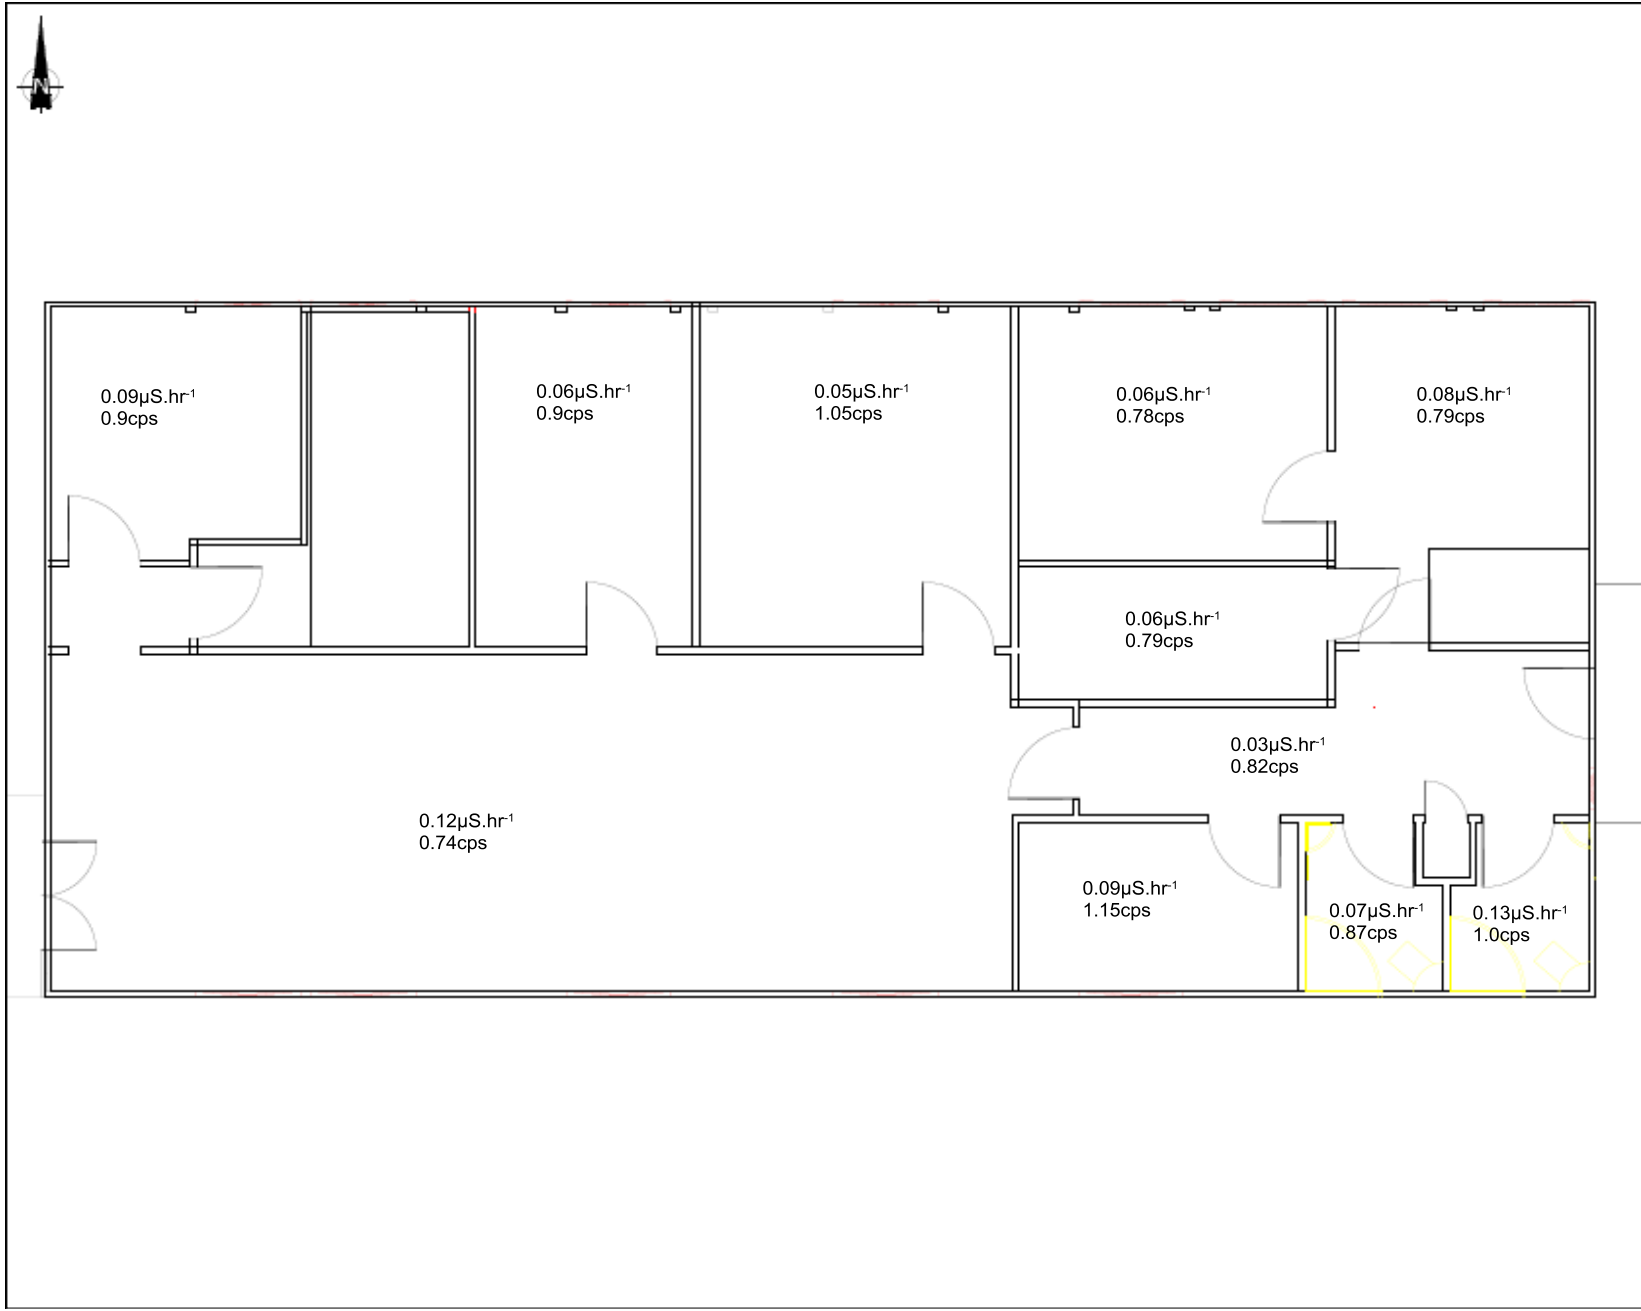
Drawing 1
 Maximum Measured
 Radiation Measurements
 In Each Room.

Maximum Geiger Counter readings and dose were recorded for each room, see appended Drawing 1. For the overall building the maximum dose was 0.13 $\mu\text{S}\cdot\text{hour}^{-1}$ and the Geiger Counter recorded up to 1.15 counts per second (cps).

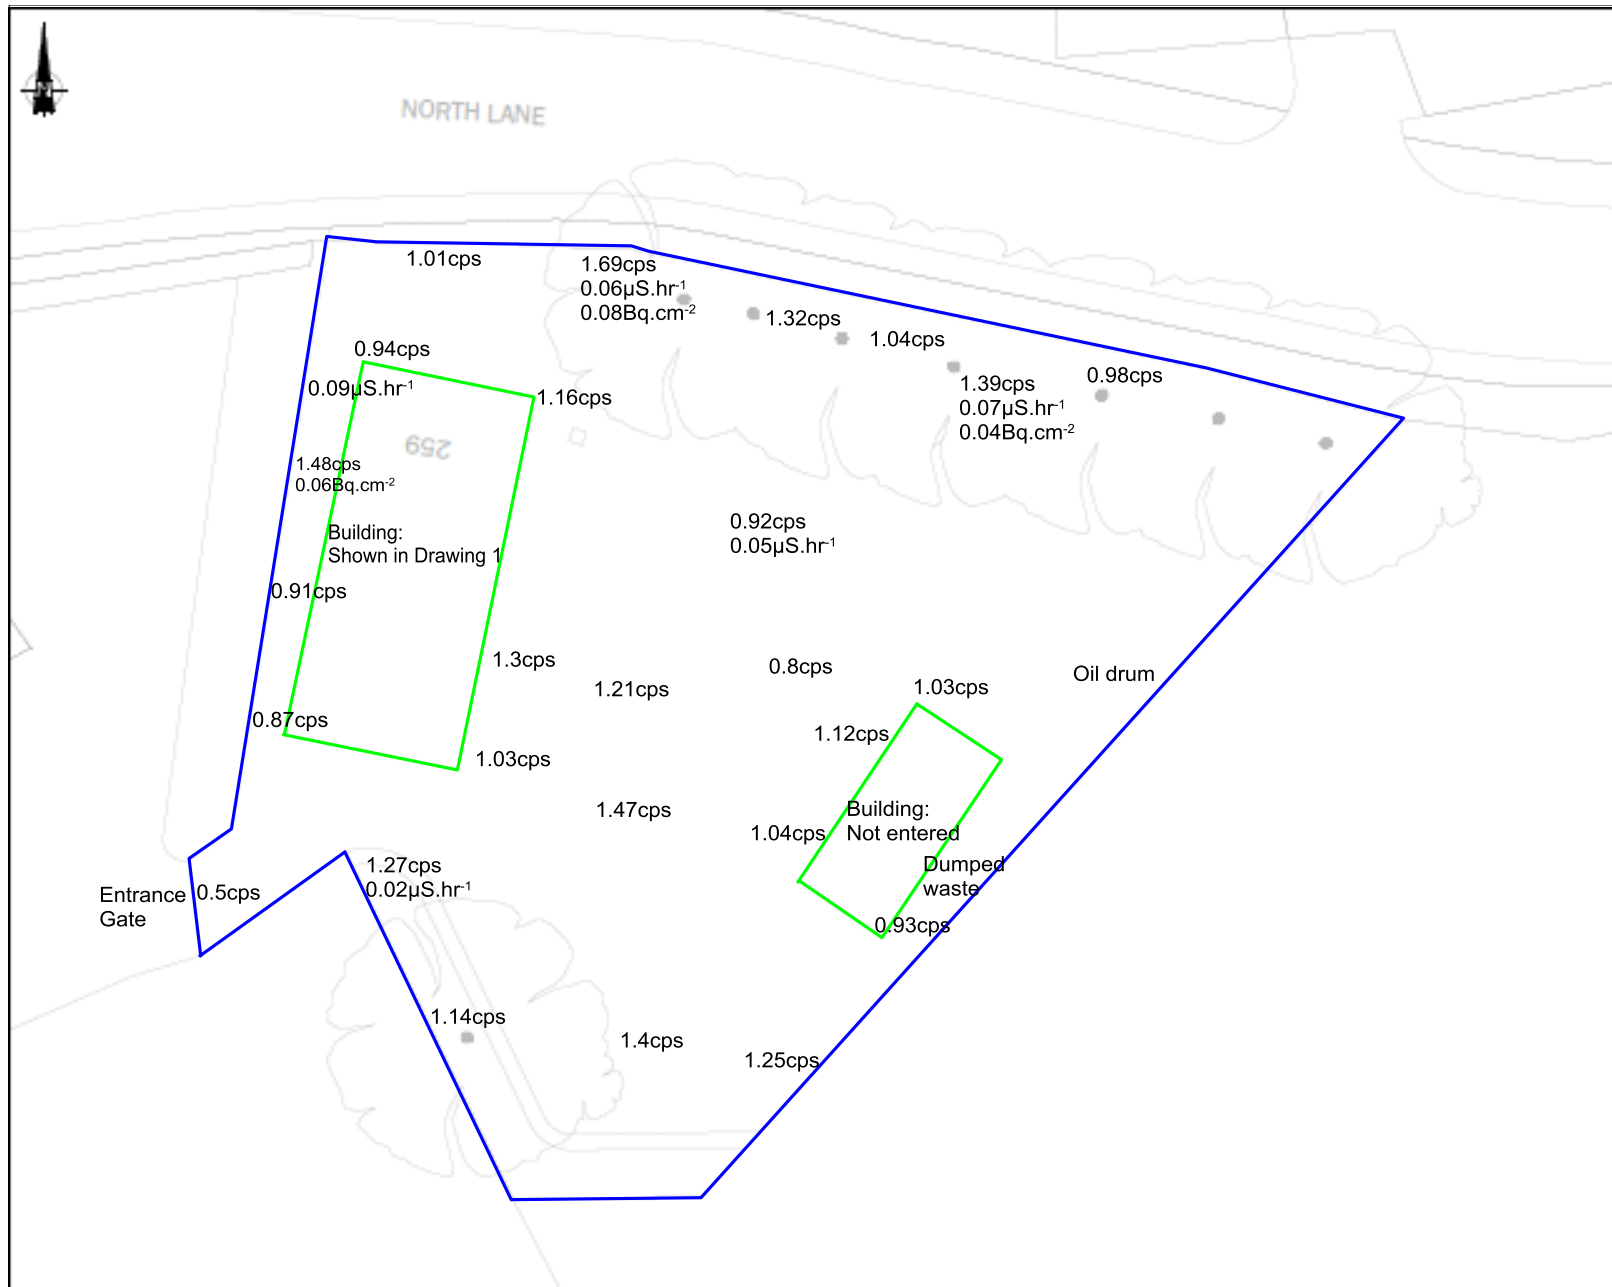
Drawing 2
 Approximate Locations
 of Locally High Radiation
 Measurements.

have identifiable markings and tyres in the shrubbery on the site boundary. We also noted that a significant volume of fly tipped waste has been dumped in the area between the 'garage' and the site fence. There may be a requirement by the Local Authority Environmental Health officer to undertake some limited investigation of these areas following appropriate removal and disposal of this waste to show that these areas are free of contamination (not necessarily radioactive but rather heavy metals, solvents, petroleum hydrocarbons). A walkover was then conducted around the grounds, with peak readings being roughly marked on a site plan, see appended drawing 2. The maximum dose recorded was $0.09\mu\text{S}\cdot\text{hour}^{-1}$ and the Geiger Counter recorded up to 1.69cps. Where some higher cps were measured, predominantly on the northern boundary of the site, Becquerel/s/square centimetre were recorded with a maximum of $0.08\text{Bq}\cdot\text{cm}^{-2}$.

With regards to radioactivity, the site is considered to pose minimal risk to the proposed site users. Areas of locally higher counts per second may be excavated to reduce this risk further prior to capping.

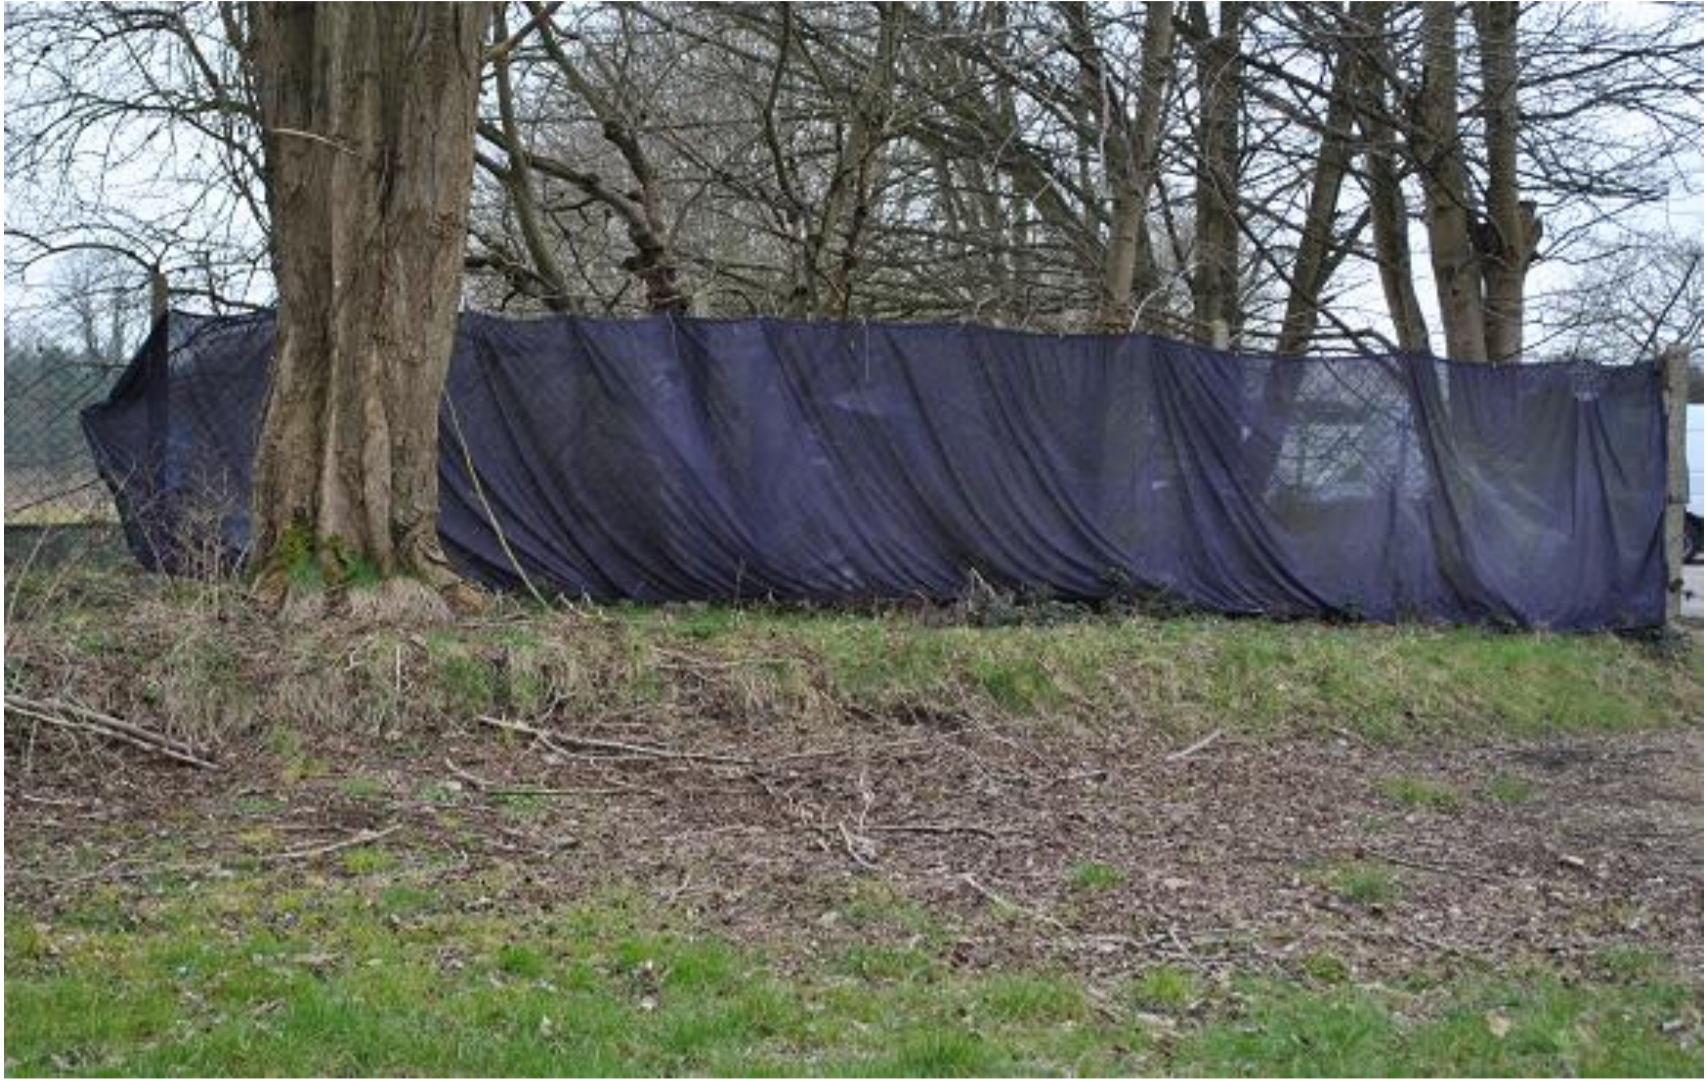
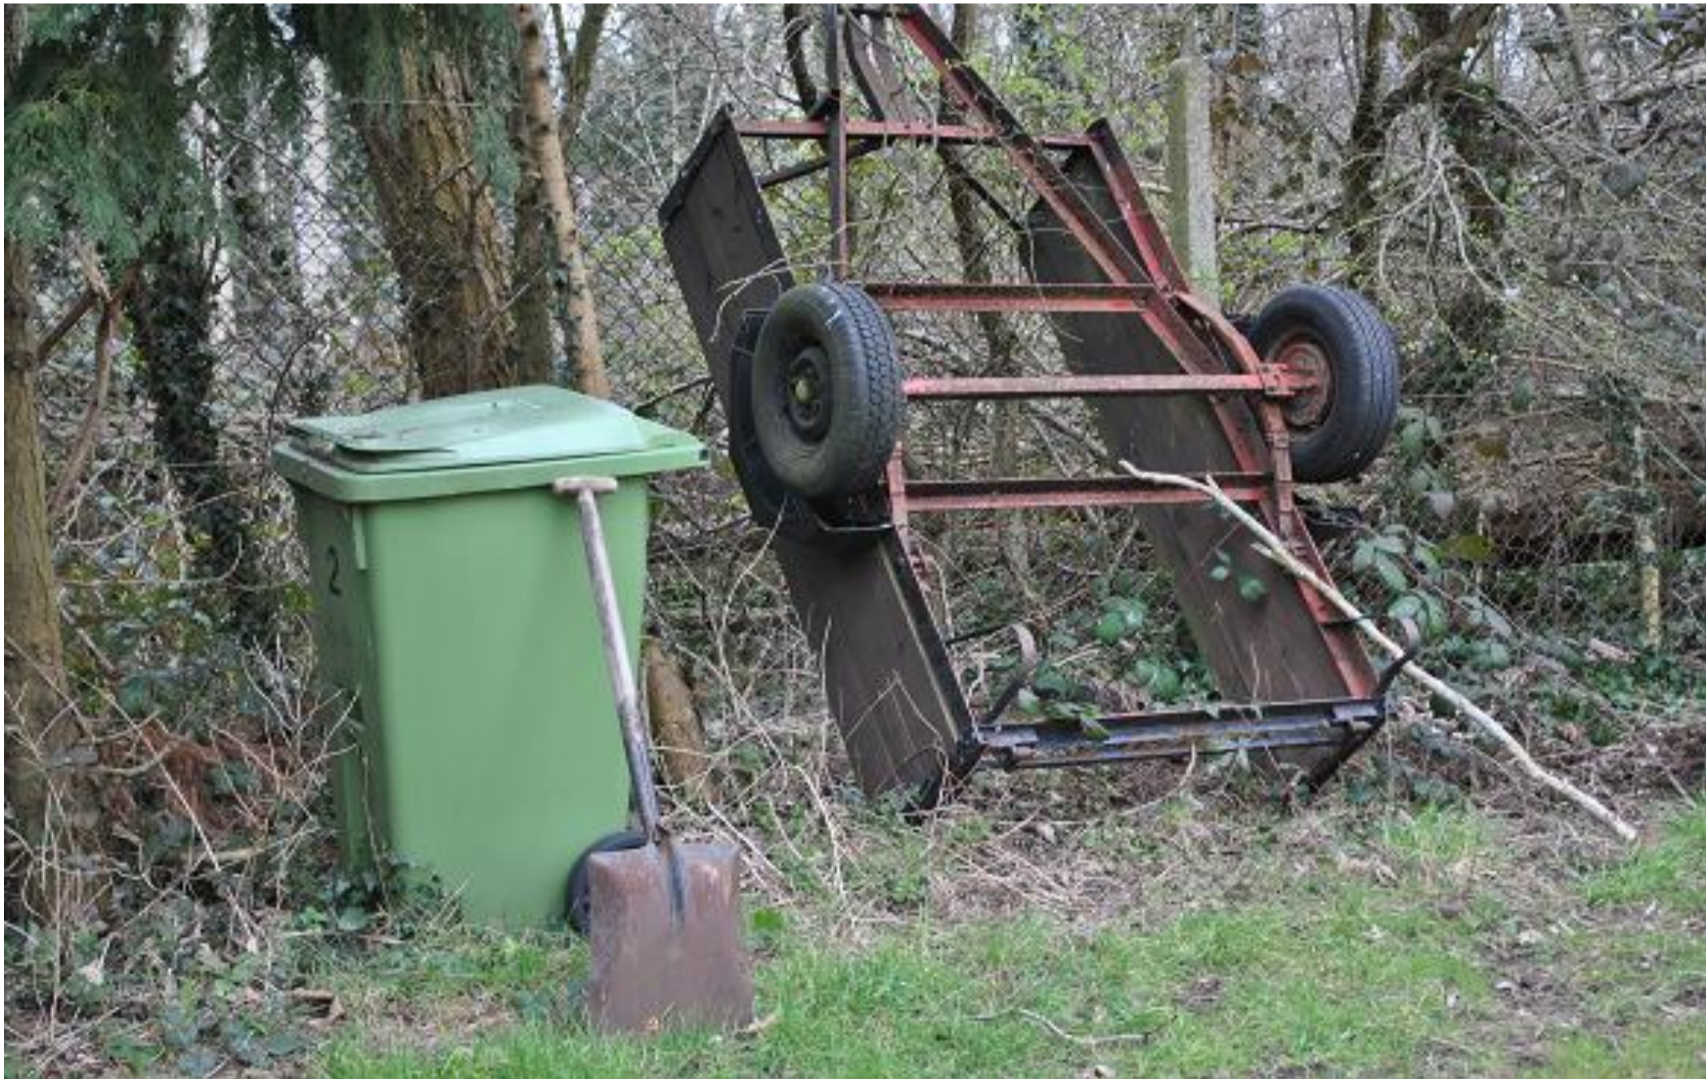
Created By:
 Photo No:
1 & 2

Photo Title:
1) Raised ground level at site boundary, 2) Rubbish on the western boundary of the site.

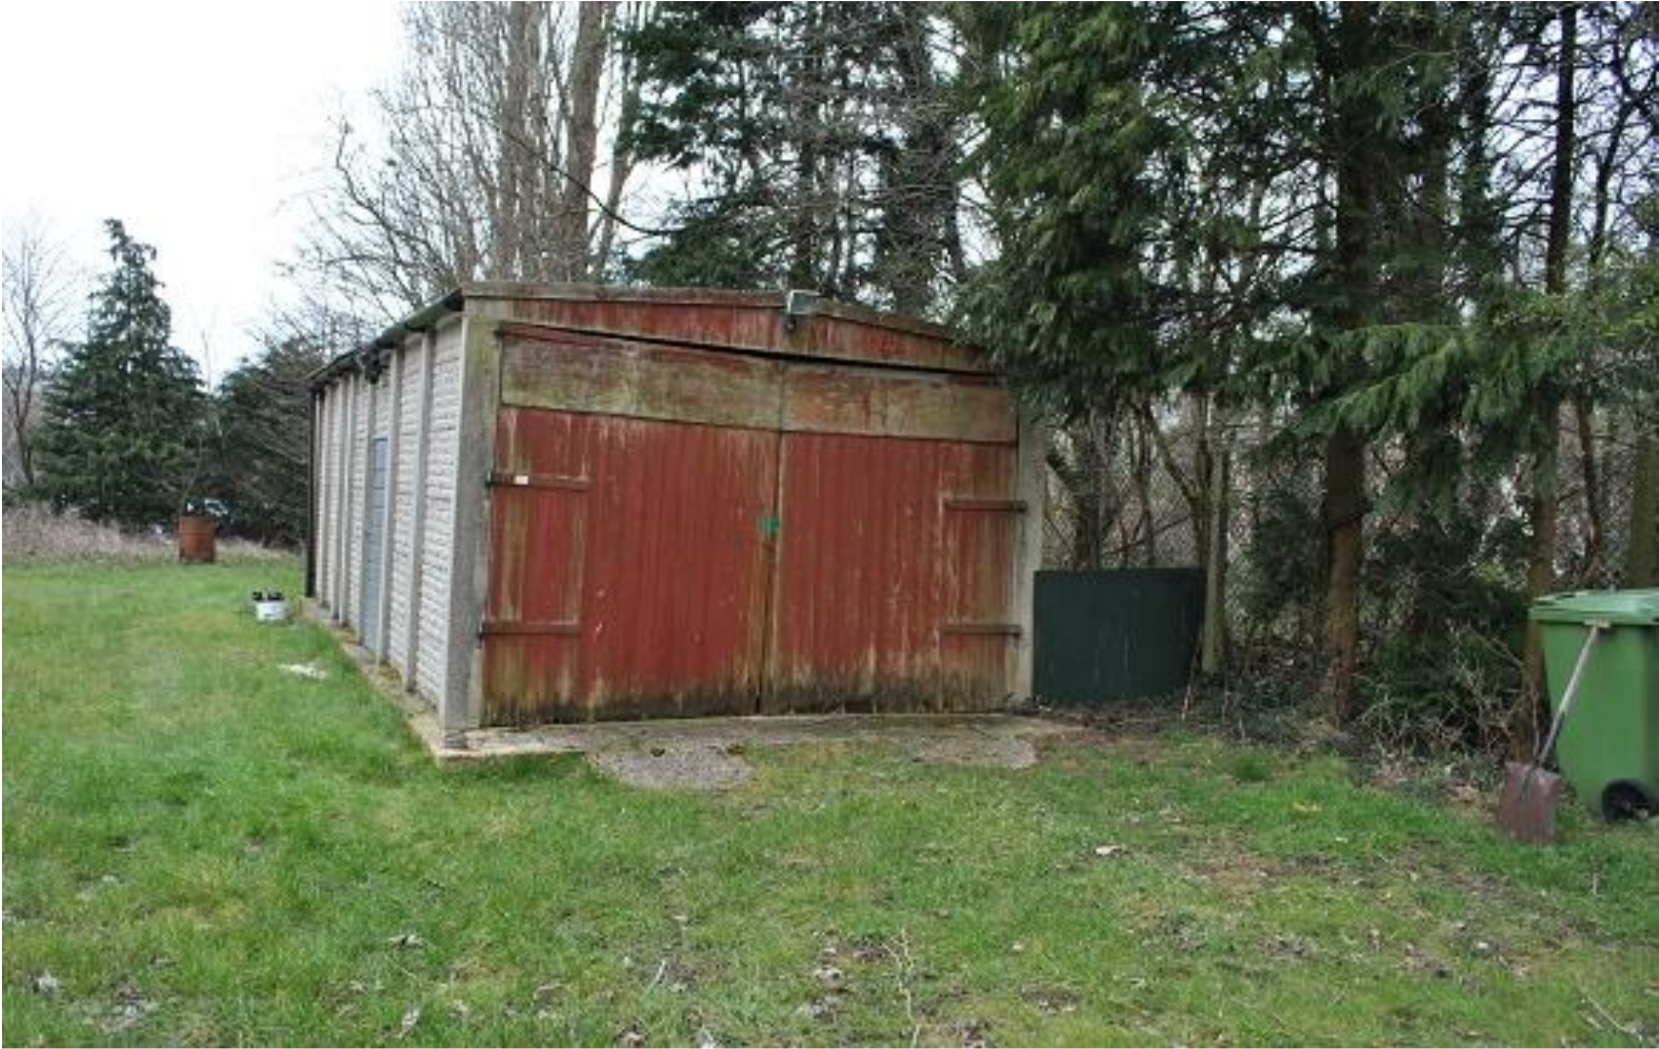
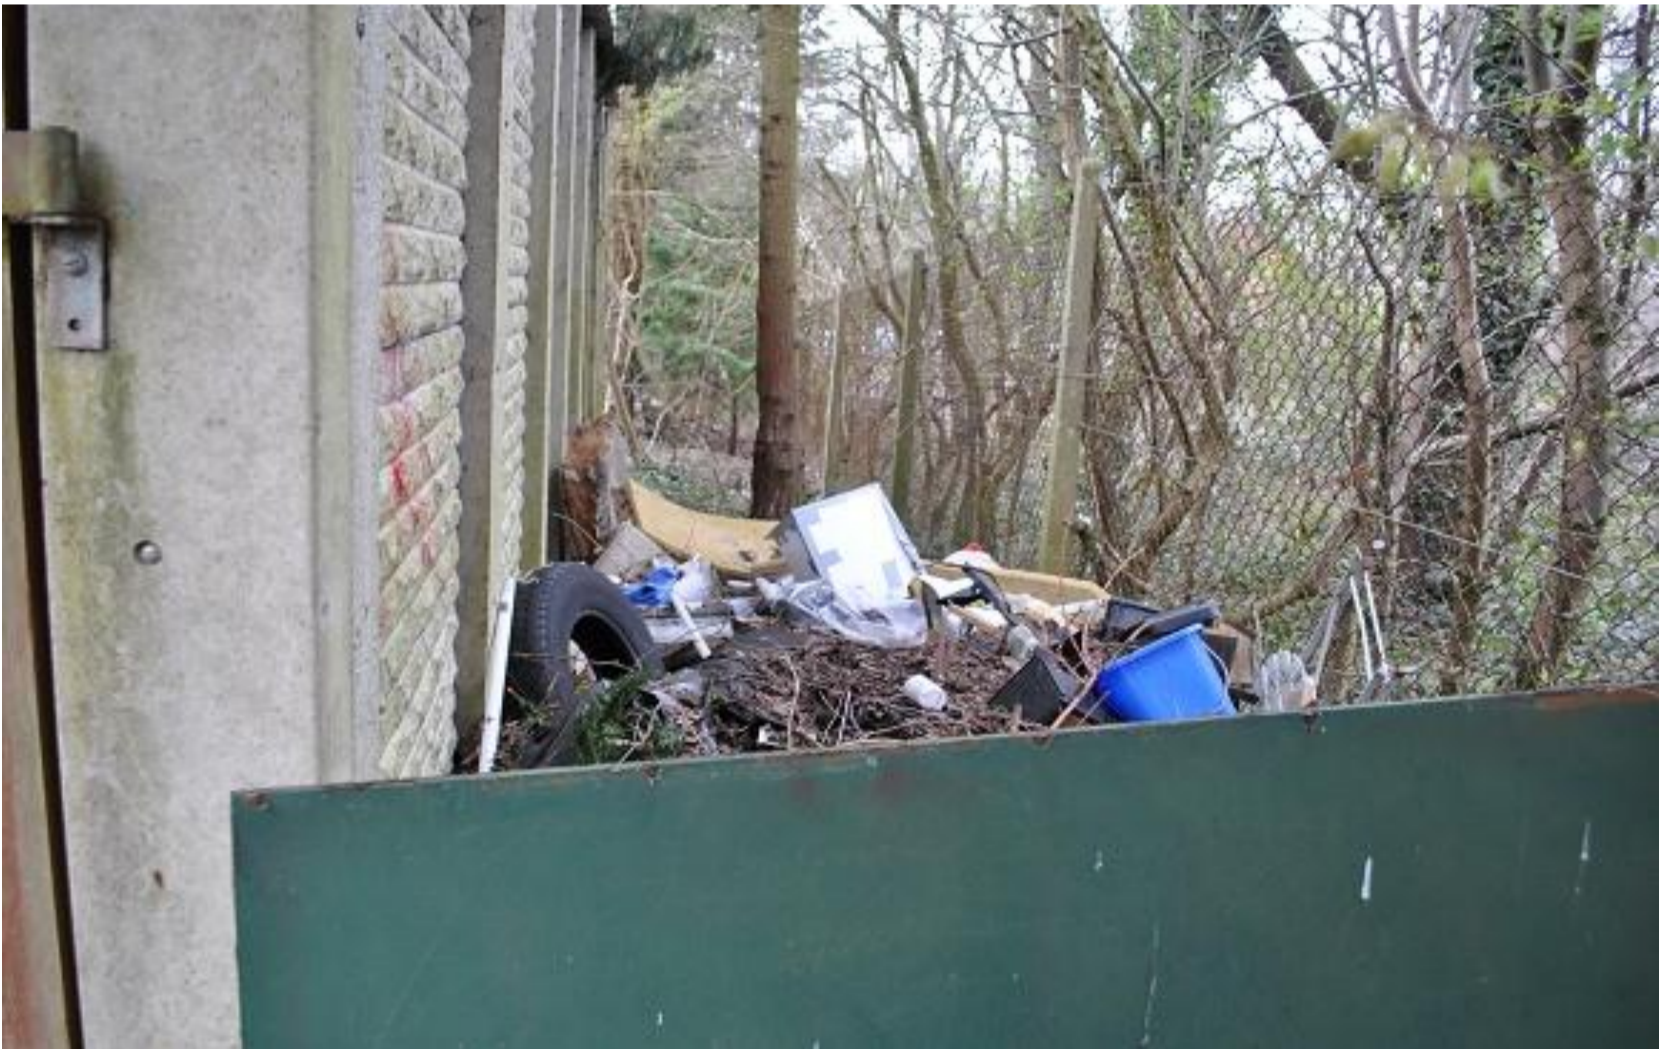
Photo Title:
 3) Ancillary building with area of dumped rubbish and an empty drum, 4) Dumped rubbish between the building and the western boundary.
 Created By:
 Photo No:
 3 & 4

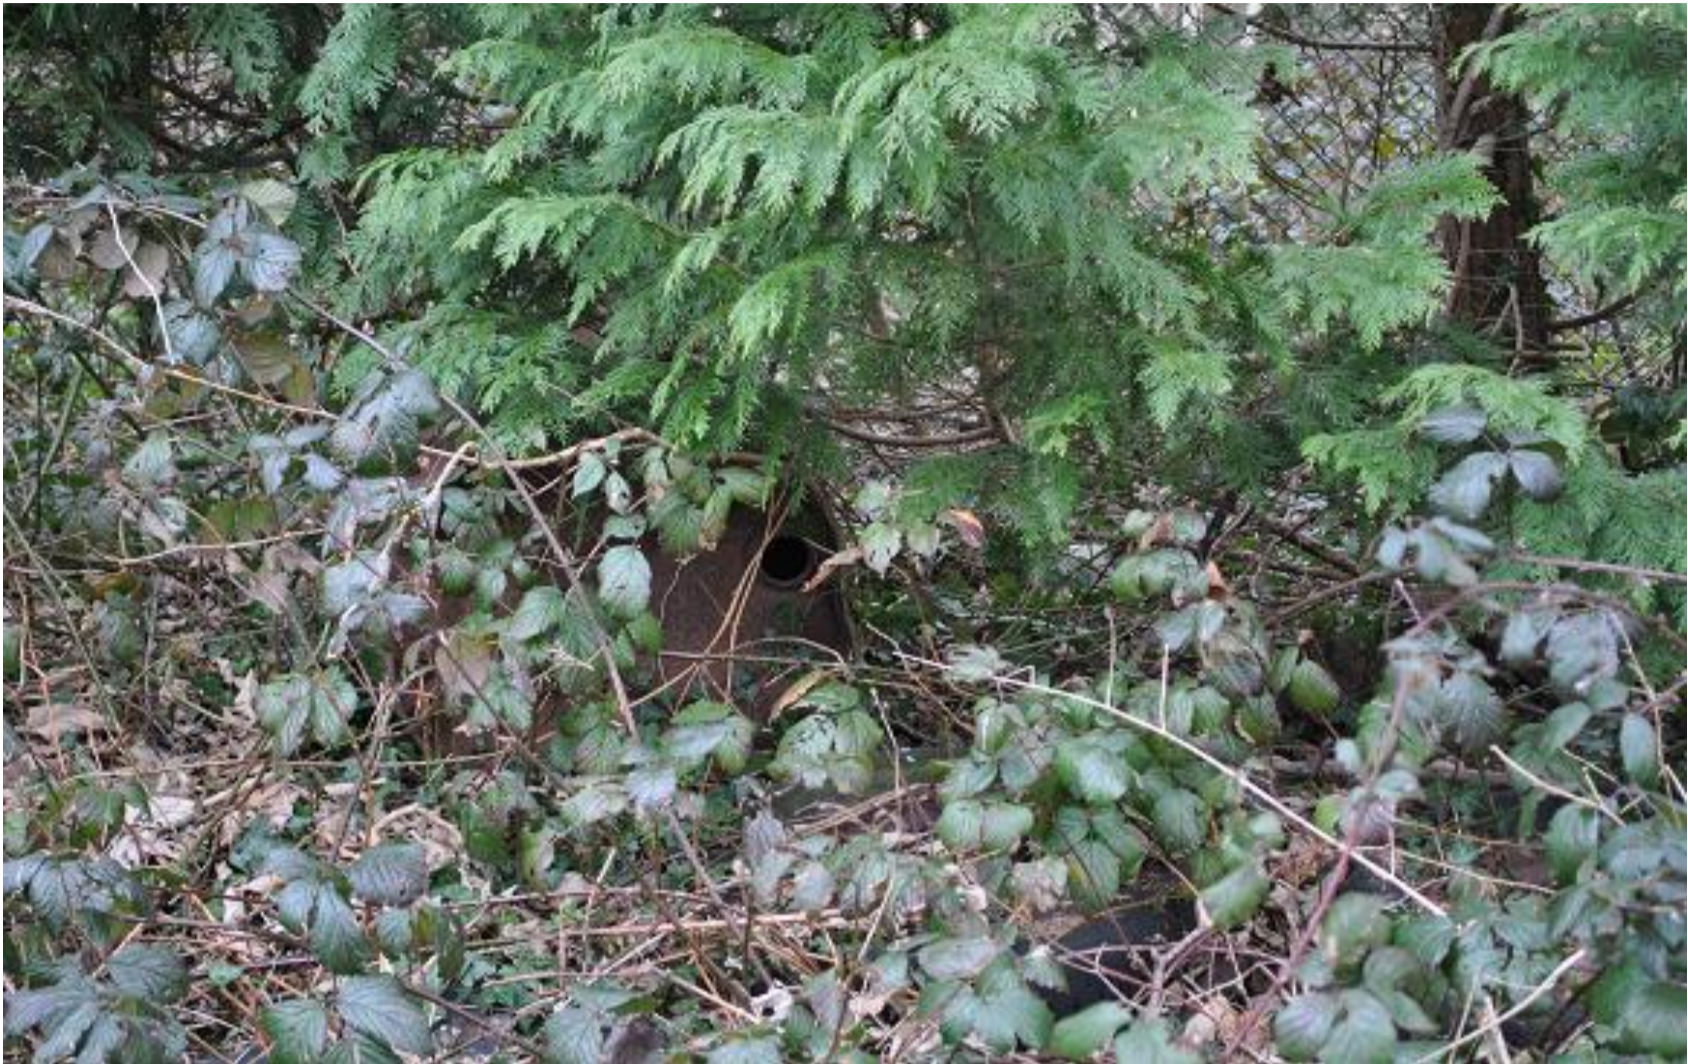
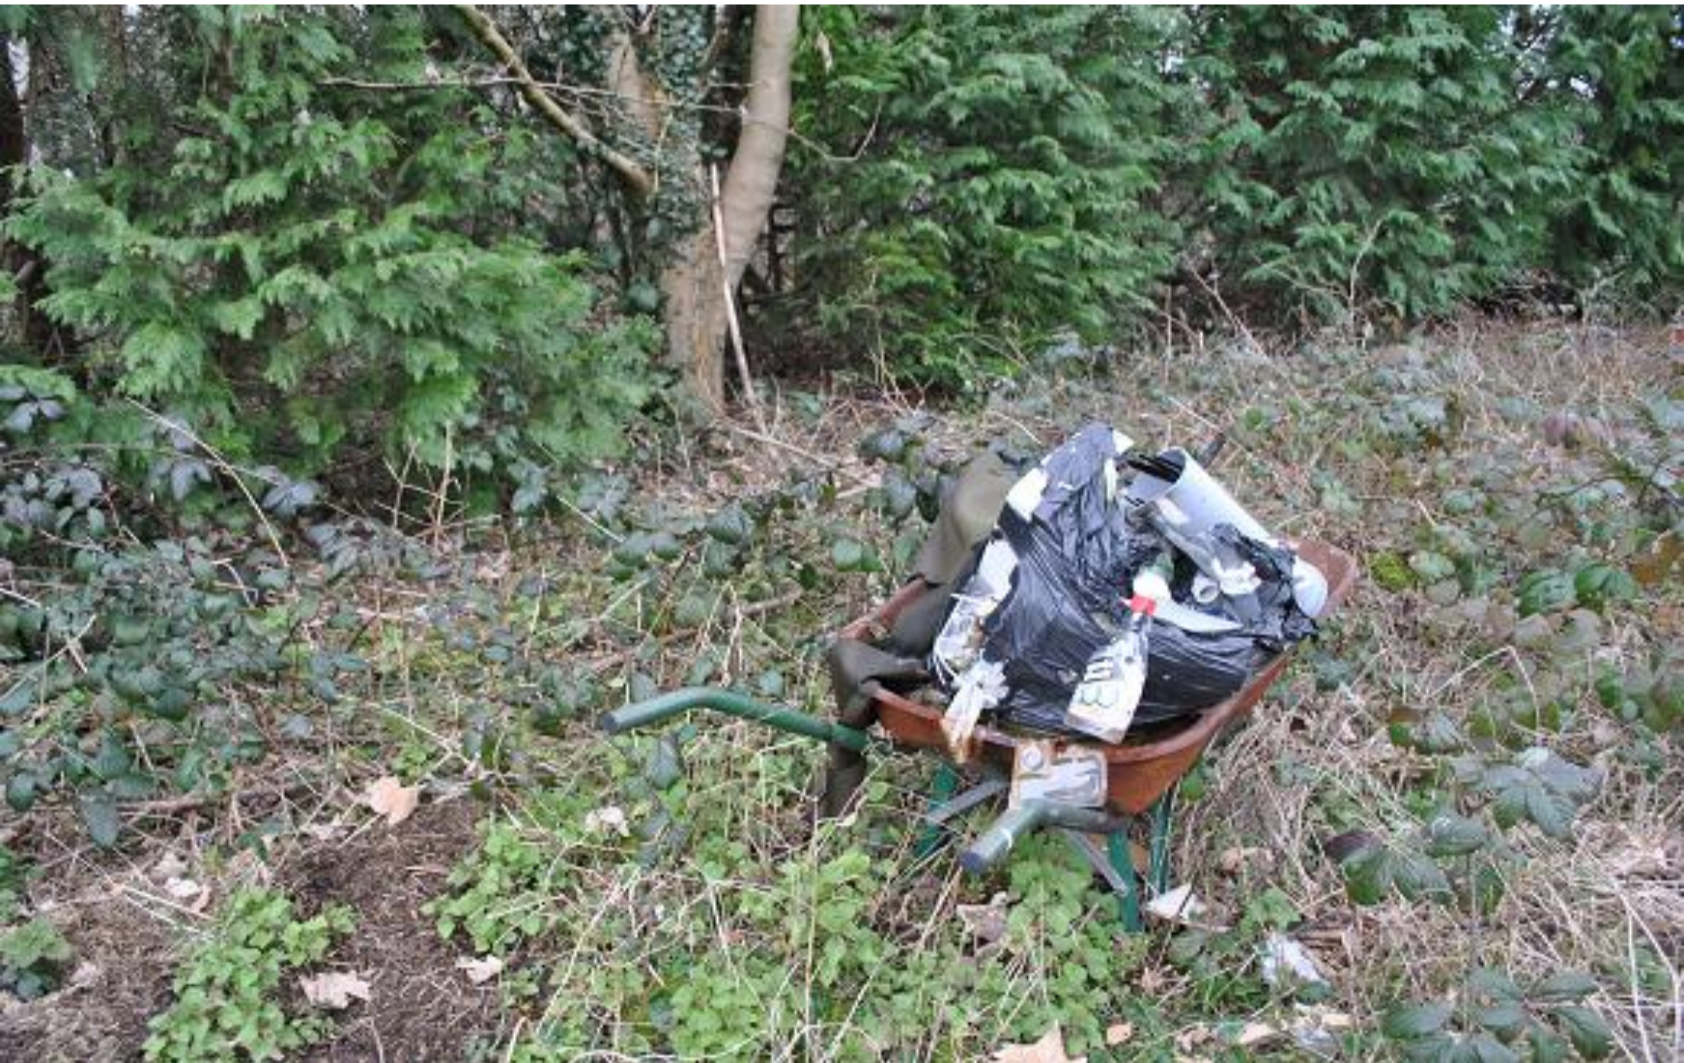
Photo Title:
 5) Drum found within the vegetation at the edge of the site,
 6) Wheelbarrow of rubbish.
 Created By:
 Photo No:
 5 & 6

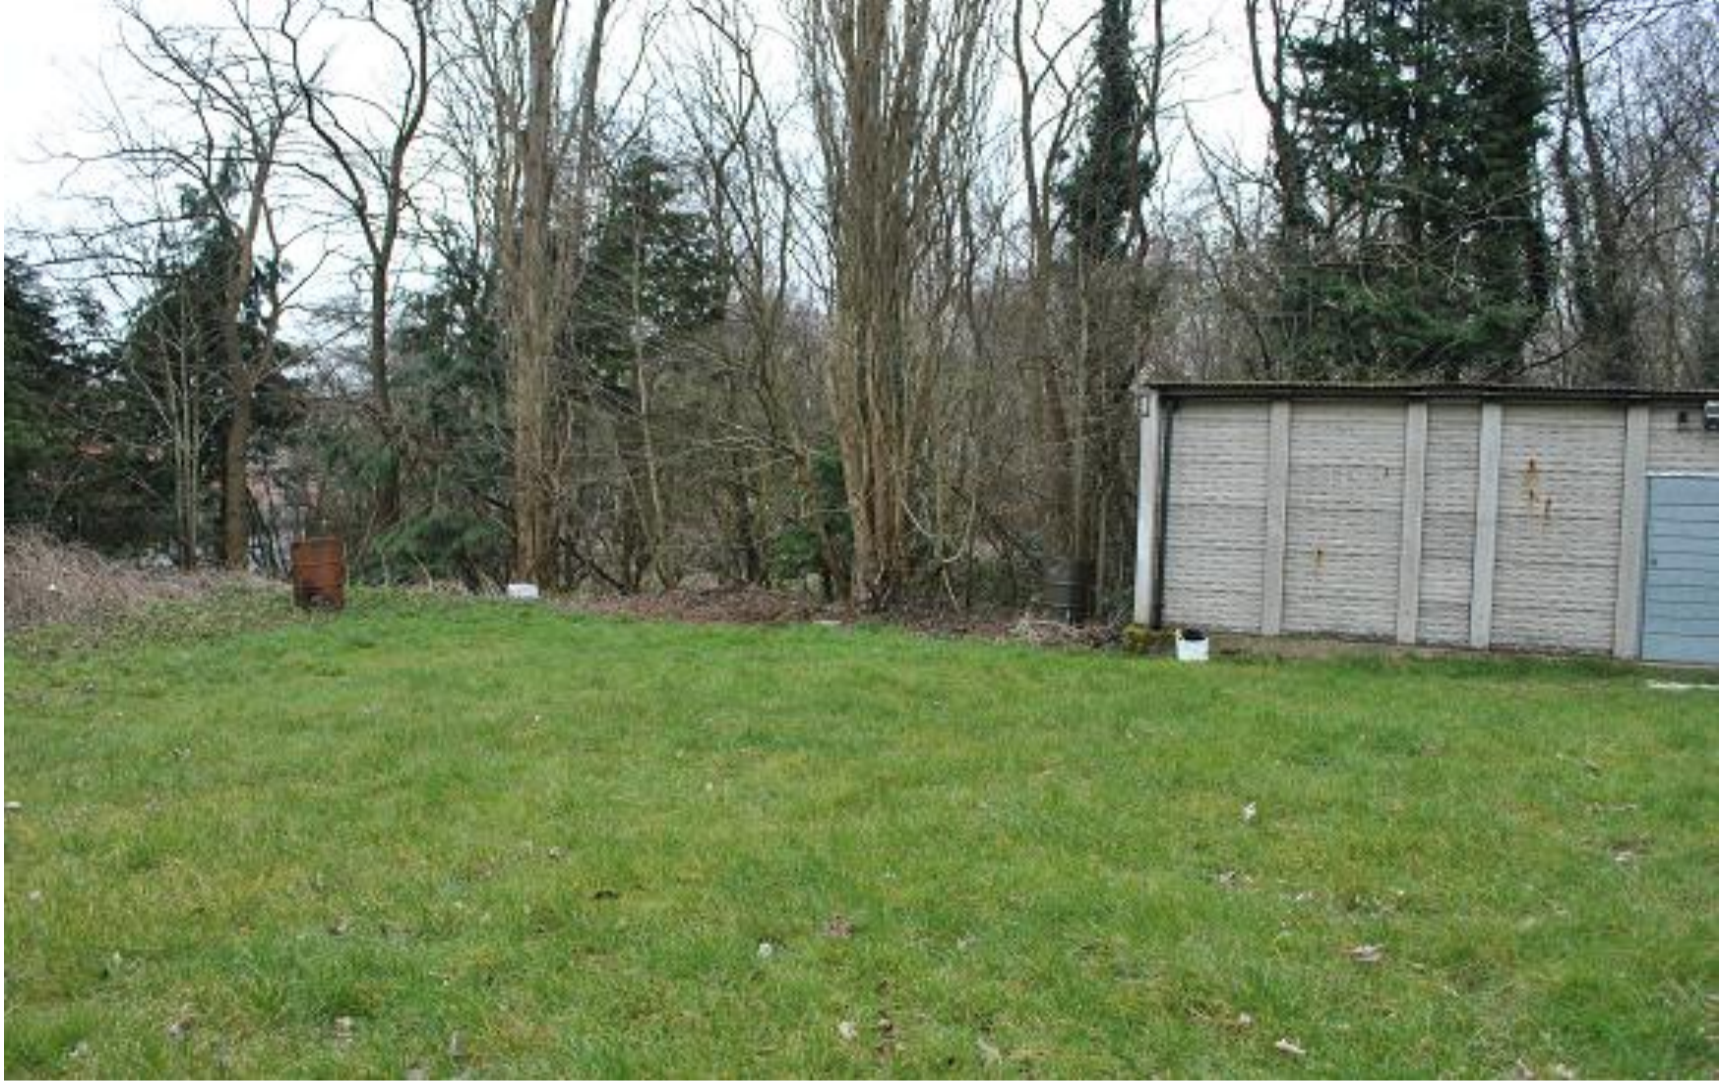
Photo Title:
7) Two drums present to the south of the ancillary building.
Created By:
Photo No:
7

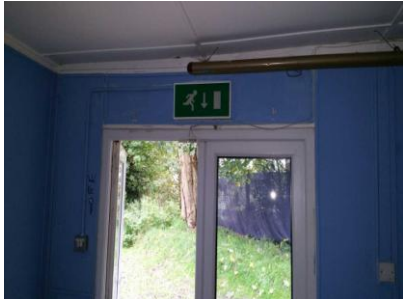
Location	Justification	Photo
Panelling above main entrance.	The product is very unlikely to contain asbestos or have asbestos added (e.g. wallpaper, plasterboard etc).

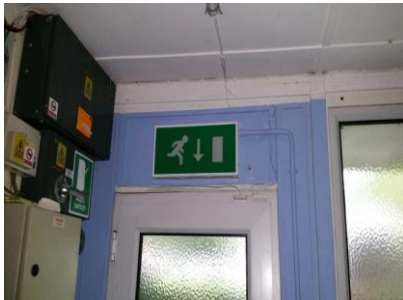
Panelling above rear entrance.	The product is very unlikely to contain asbestos or have asbestos added (e.g. wallpaper, plasterboard etc).

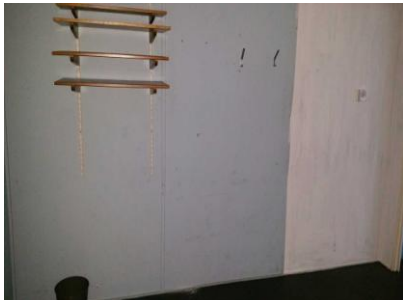
Internal partitioning.	The product is very unlikely to contain asbestos or have asbestos added (e.g. wallpaper, plasterboard etc).
